# **CONSERVATION MANAGEMENT PLAN**

**FOR  
THE FORMER CLUNES  
PRIMARY SCHOOL NO 136  
CLUNES BOTTLE MUSEUM  
70 BAILEY STREET, CLUNES,  
VICTORIA 3370**

**MAY 2017**

**PREPARED BY AMANDA JEAN**

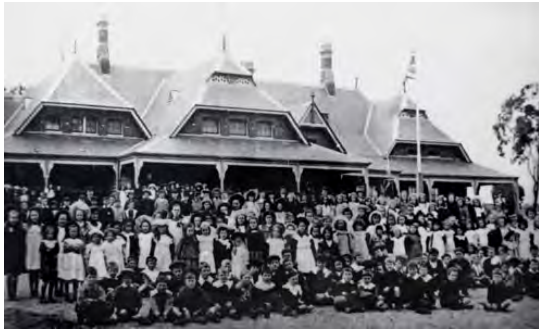
In the late 1878s a new style of school design was introduced, exemplified by the Avoca State School 1878. The design was innovative and addressed specific climate conditions faced by hot arid conditions of rural Victoria. The designs were mainly in the rural Picturesque Gothic architectural style. This period of school development across Victoria was also marked by the large number of additions to existing schools, the provision of detached residences, and the building of a number of architecturally impressive large urban schools. The latter were predominantly in the Gothic style, with polychrome brickwork, and steeply pitched slate roofs punctuated with dormer vents, finials, elaborate chimneys and a picturesque bell tower.

Avoca State school no.4, 1878: Photographs of State School Buildings. Department of Education: VPRS 1396-p0-3: Reproduced with permission of the keeper of public records, Public Records Office of Victoria.

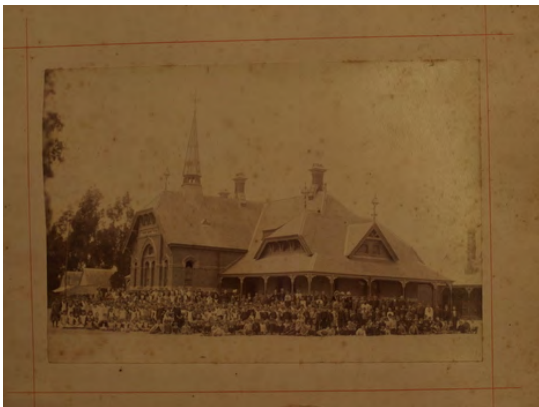
South Clunes State School rebuilt in 1881/1882 in the rural Picturesque Gothic style. View to the left side of Mr Kempson's school established in 1857. Reproduction Victorian Collection, Clunes Museum, State Library of Victoria.

The South Clunes school design is very similar to the Avoca School, without verandahs extending across the front and incorporation of the metal fleche tower. In addition, the jerkin style gables are single rather than double. The Avoca school was designed to accommodate 1000 students while the South Clunes school between 500-700 students.

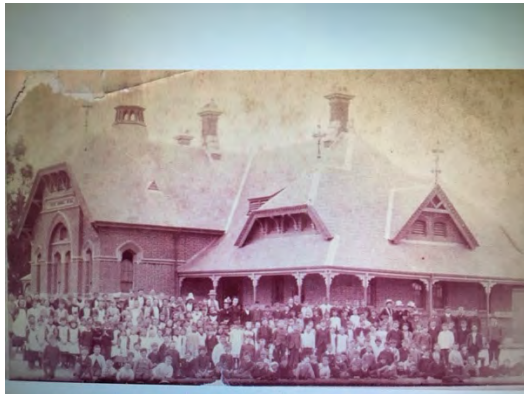
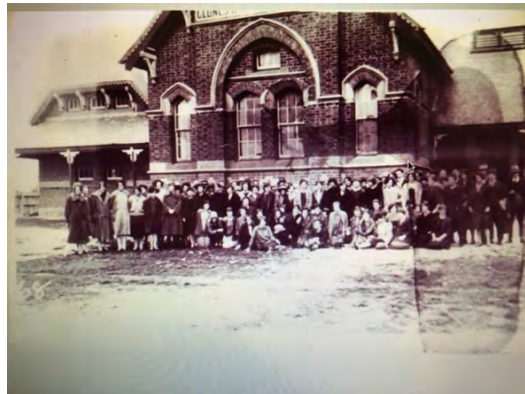
South Clunes School, Reproduction Victorian Collections, Clunes Museum, State Library of Victoria

Note the very tall elaborate Gothic styles metal finials on each gable, the jerkin bracketed gablets and upper clerestory rows of windows and exemplary polychrome brick walls.

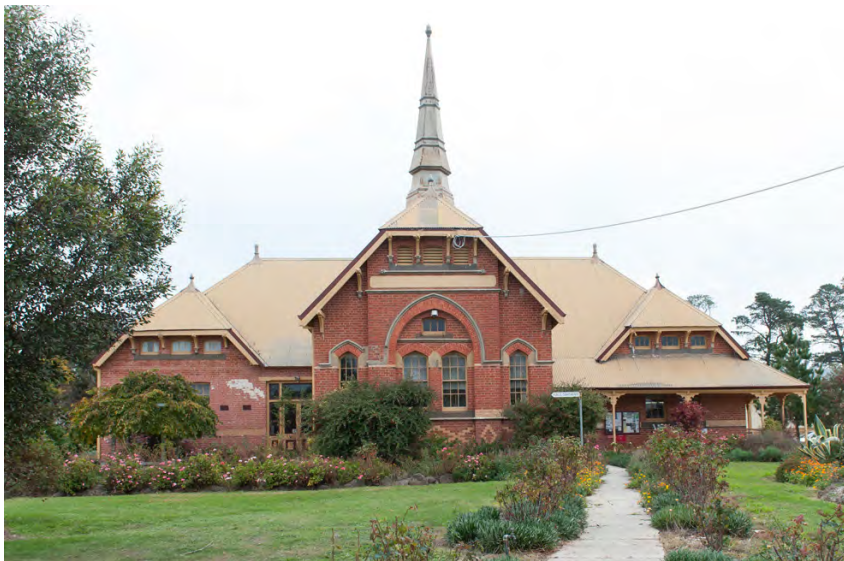
Front entrance facing Bailey Street, Clunes.

The roof is elaborately designed with jerkin head, half hip form gables, dormers and tall decorative chimneys. The original roof ventilation system and vents were removed when the original slate roof tiles were replaced.

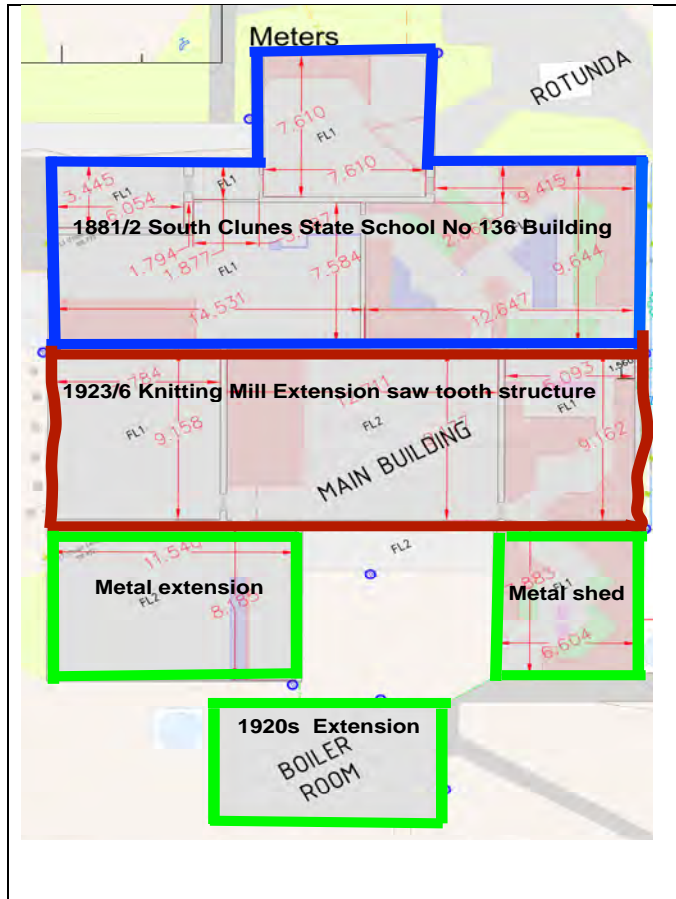
1881/1882 original school building

1923/1926 extension to incorporate the Clunes Knitting mill

Boiler House

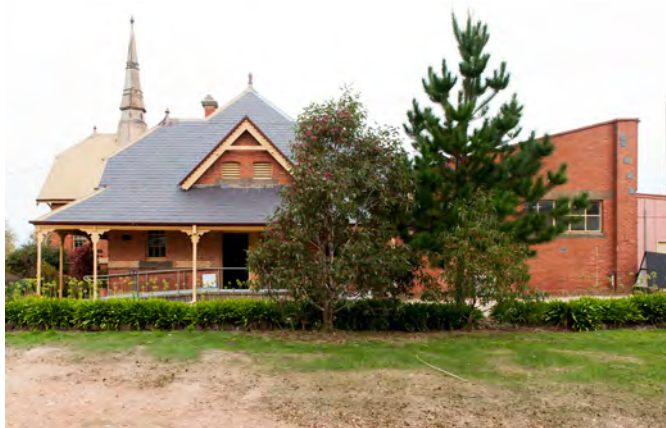
The South Clunes School was constructed in 1881-1882, to the design by Henry Robert Bastow on the hill overlooking Creswick Creek and the South Clunes mine. Bastow was at the time the architect to the State Schools Division of the Public Works Department. Stylistically the building is derivative of Victorian Rustic Gothic, using free interpretation of medieval motifs which was characteristic of Bastow's style.

It belongs to a series of mainly rural schools, where the use of the verandah is a major element in the design. The verandah is well integrated with the design, extending all around the building, except for on the east double storey side. Here the lower windows are shaded deep bracketed window hoods. The building is constructed in polychrome red, brown and blond brick with blue stone foundations and is constructed in a simple rectangular plan form with projecting front room.

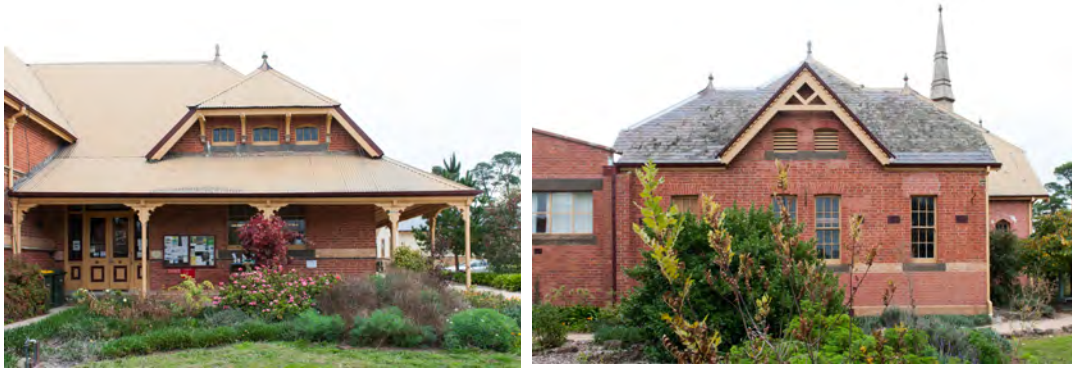
The roof construction is of timber trusses of various forms. The original slate roof has been replaced with new slate tiles, while the front section of the roof has been replaced with green colourbond which has now changed to a dull yellow olive colour. The complex and varied steep roof forms are highlighted by finials, strutted gables ends and hoods, jerkin gable ends, and high dormer windows. The roof vents have been removed.

The whole affect is crowned by a tall hexagonal fleche located in the center of the main projecting gable ridge. To either side, the roofs extends over a deep verandah. The verandah posts have bracketed capitals. The verandahs to the east wing were removed during the 1950s for extension to the knitting mill.

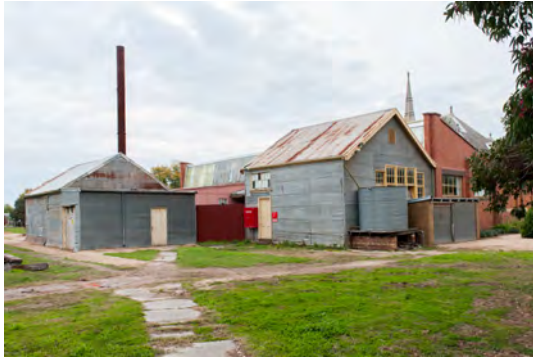
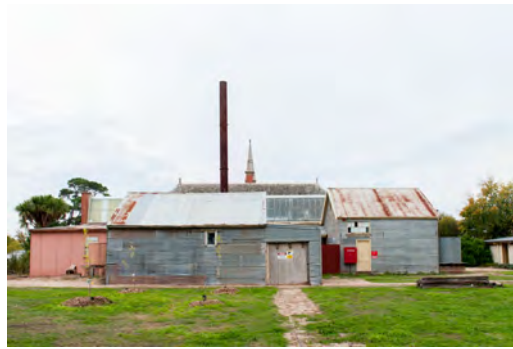
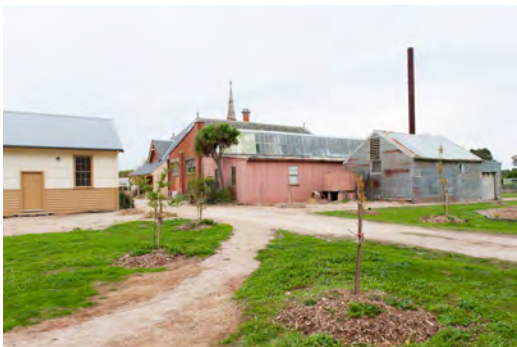
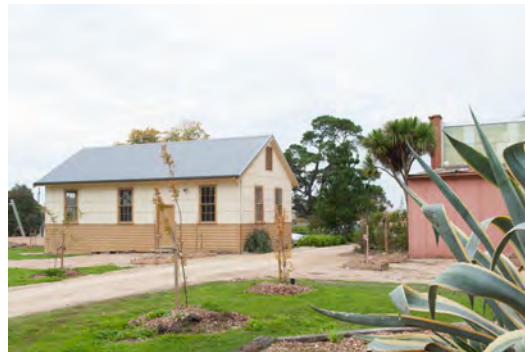
In 1923 a large rectangular saw tooth industrial extension was added across the rear of the school building. The addition most likely resulted in the removal of rear verandahs and windows. The addition is industrial in design and construction with single leaf brick walls set between a series of externally expressed brick piers supporting a angles metal truss saw tooth roof. A series of upper level bank of windows were incorporated between the piers providing natural daylight to the interior.

Several metal sheds were constructed abutting the factory with a detached metal structure to house the large boilers. The images above show the juxtaposition of the metal buildings and boiler room, the mid 20<sup>th</sup> century brick toilets and recently restored small rectangle simple ridge roomed lunch room.

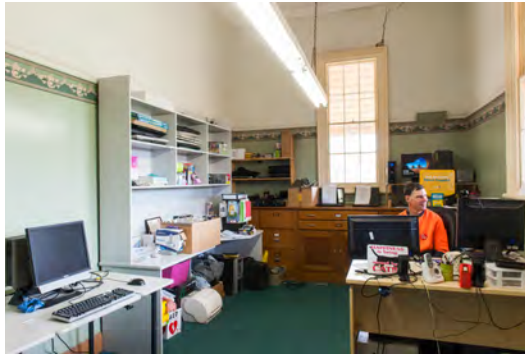
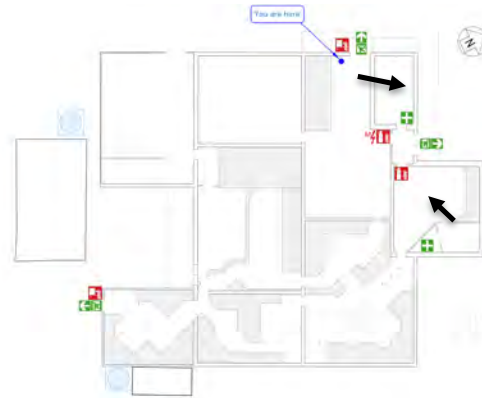
**Room 12: West Front Office.**

The entrance to the school building is small narrow and the original ceiling, which is still intact, is part of the roof structure of the class room behind. The west front entrance is duplicated by the entrance to the east. The roof design is complex but apart from the missing roof vents, is intact to its original configuration. The large class room located behind the central projecting gable room receives natural day light from the glazed entrance doors, high roof lights and banks of clerestory windows on the south wall, and also from the row of windows on the west and east exterior walls. The main building consisting of four large spaces is designed like a massive tent.

It is unclear whether there were ever internal corridors extending from the from the two front entrances to the rear. It is highly probable that there were windows on the exterior south walls.

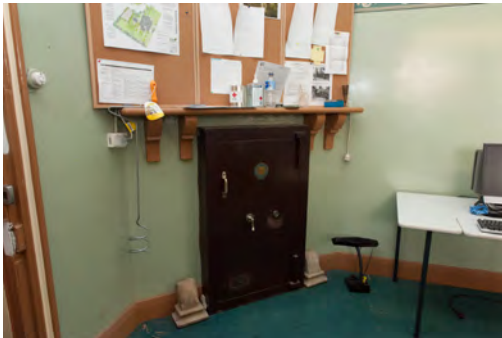
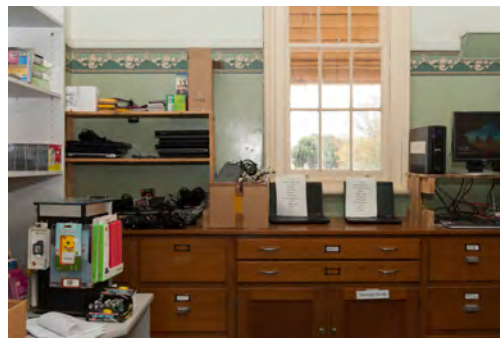
**Room 2: Central Projecting Gable Room, Bottle Museum Entrance, Office, Kitchenette.**

The Bottle Museum entrance office and kitchenette are accommodated within the most elegant space of the building. The room has been especially designed with rows of windows on three sides to allow cross ventilation and massive cathedral style ceiling. The south wall has a fire place and massive brick flue. The paraphernalia of the museum and kitchenette obscures the architectural space.

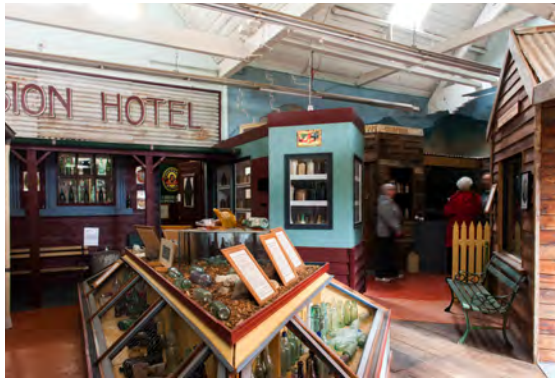
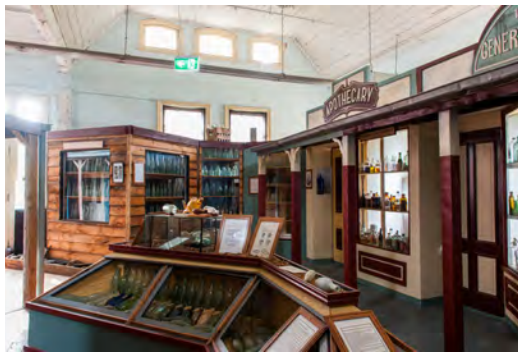
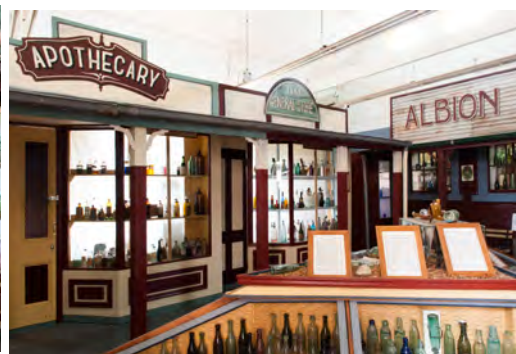
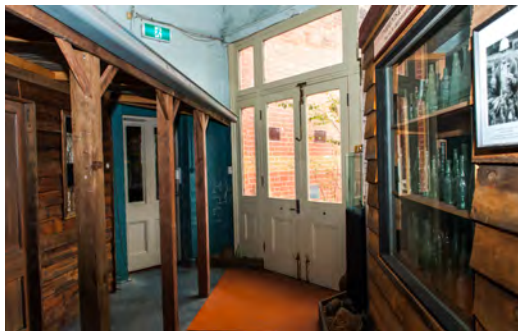
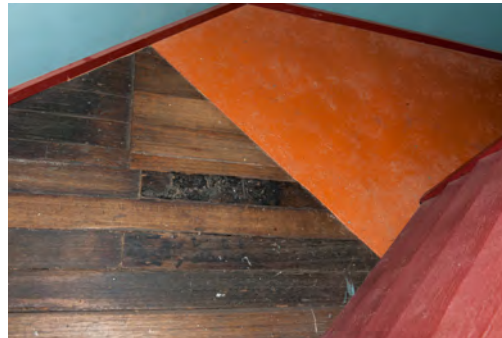
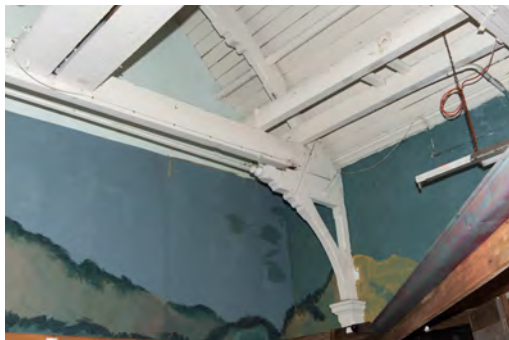
**East Front Entrance, Room 3 and Room 4: Bottle Museum Exhibition Display**

The two former classrooms were converted into the knitting mill machinery room with the installation of two massive knitting machine fixed to the floor in the centre of the space. The museum exhibitions obscure the architectural space and prevents adequate cross flow of ventilation and ambient natural light from illuminating the displays. The strong colours used on the walls and wall hugging diorama with the bright coloured partially painted timber floors further disorients visitors.
