HEPBURN SHIRE COUNCIL
ORDINARY MEETING OF COUNCIL
PUBLIC MINUTES

Tuesday 21 December 2021

1	ACKNOWLEDGEMENT OF TRADITIONAL OWNERS	5
2	OPENING OF MEETING	5
3	APOLOGIES	5
4	DECLARATIONS OF CONFLICTS OF INTEREST	6
5	CONFIRMATION OF MINUTES	6
6	NOTICES OF MOTION	6
6.1	NOTICE OF MOTION	6
7	ITEMS OF URGENT BUSINESS	9
8	COUNCILLOR AND CEO REPORTS	10
8.1	MAYOR'S REPORT	10
8.2	COUNCILLOR REPORTS	10
8.3	CHIEF EXECUTIVE OFFICER'S REPORT	14
9	PUBLIC PARTICIPATION TIME	19
9.1	PETITIONS	20
9.1.1	PUBLIC PETITION	20
9.2	PUBLIC QUESTIONS	20
9.3	REQUESTS TO ADDRESS COUNCIL	22
10	STATUTORY PLANNING	24
10.1	PA 3141 - USE AND DEVELOPMENT OF THE LAND FOR A MOUNTAIN BIKE TRAIL (INFORMAL OUTDOOR RECREATION) AND THE REMOVAL OF NATIVE VEGETATION - CRESWICK TRAILS	24

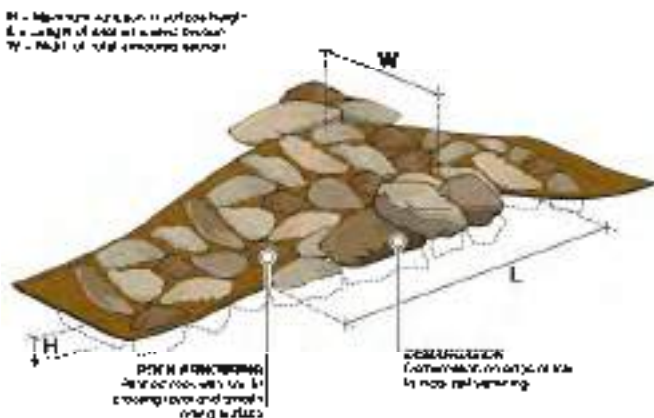
Typical rock armouring, extract from Trail Development Plan

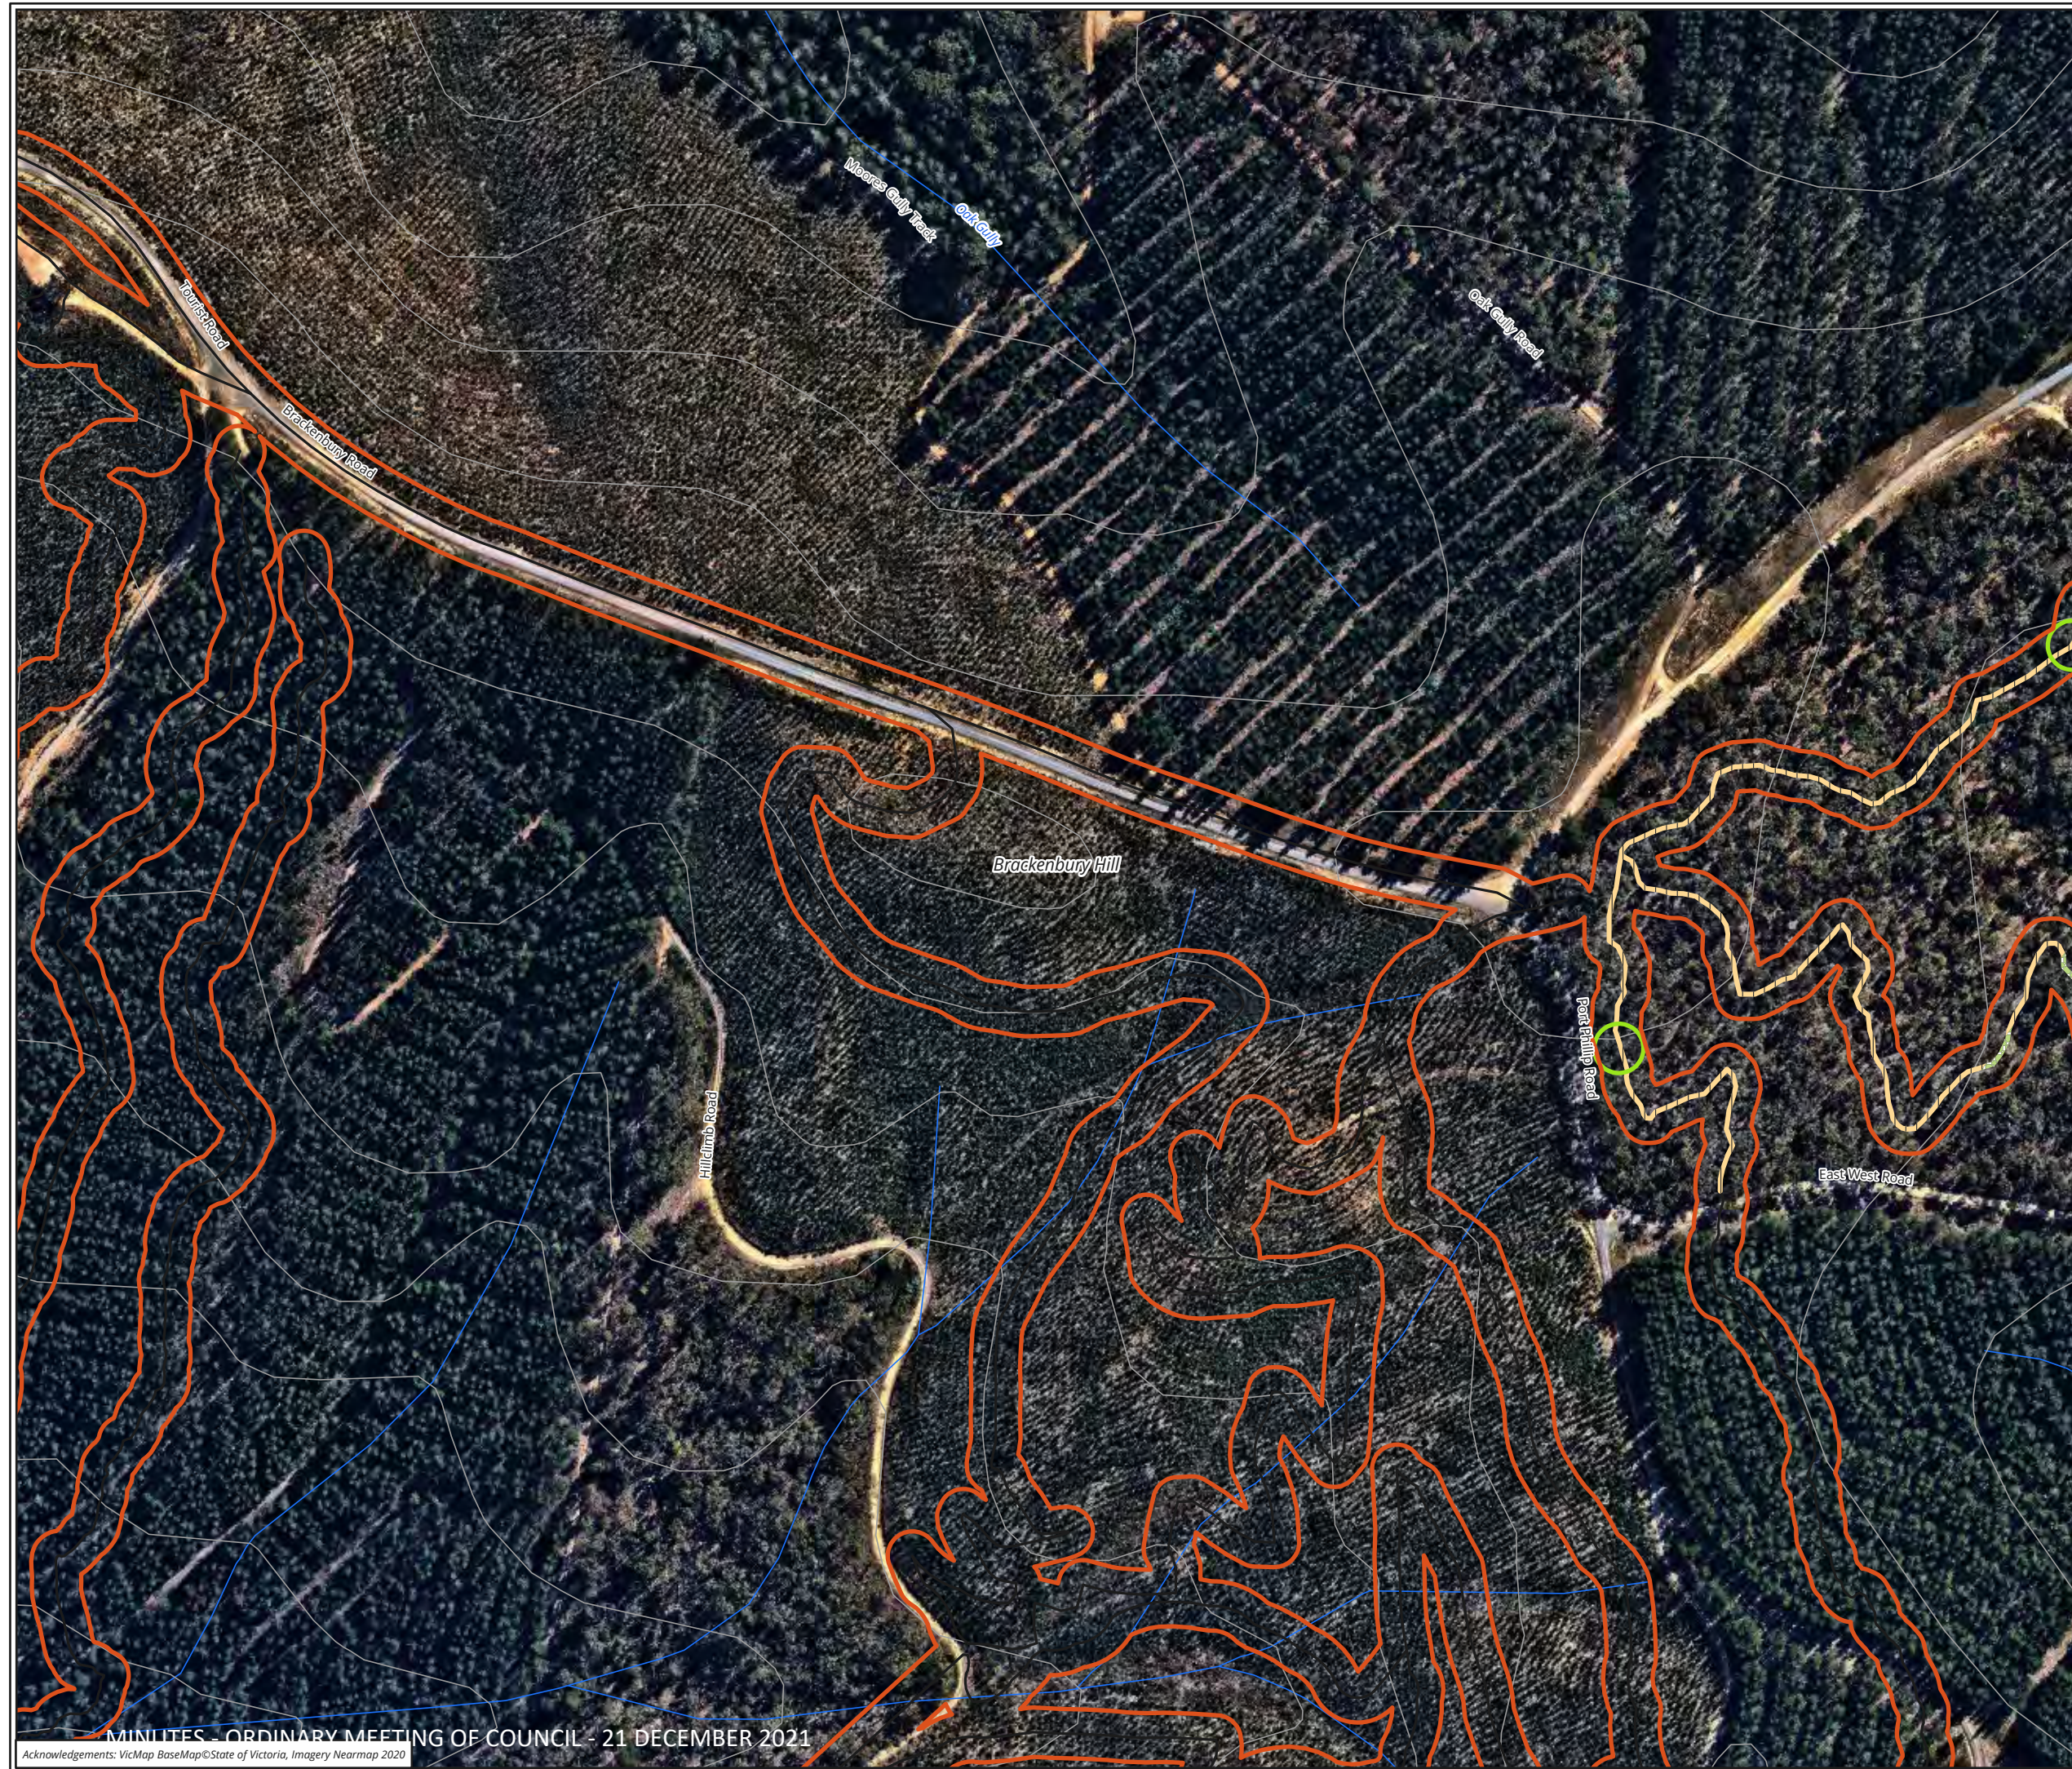
Figure 3.5 Proposed vegetation removal within the study area

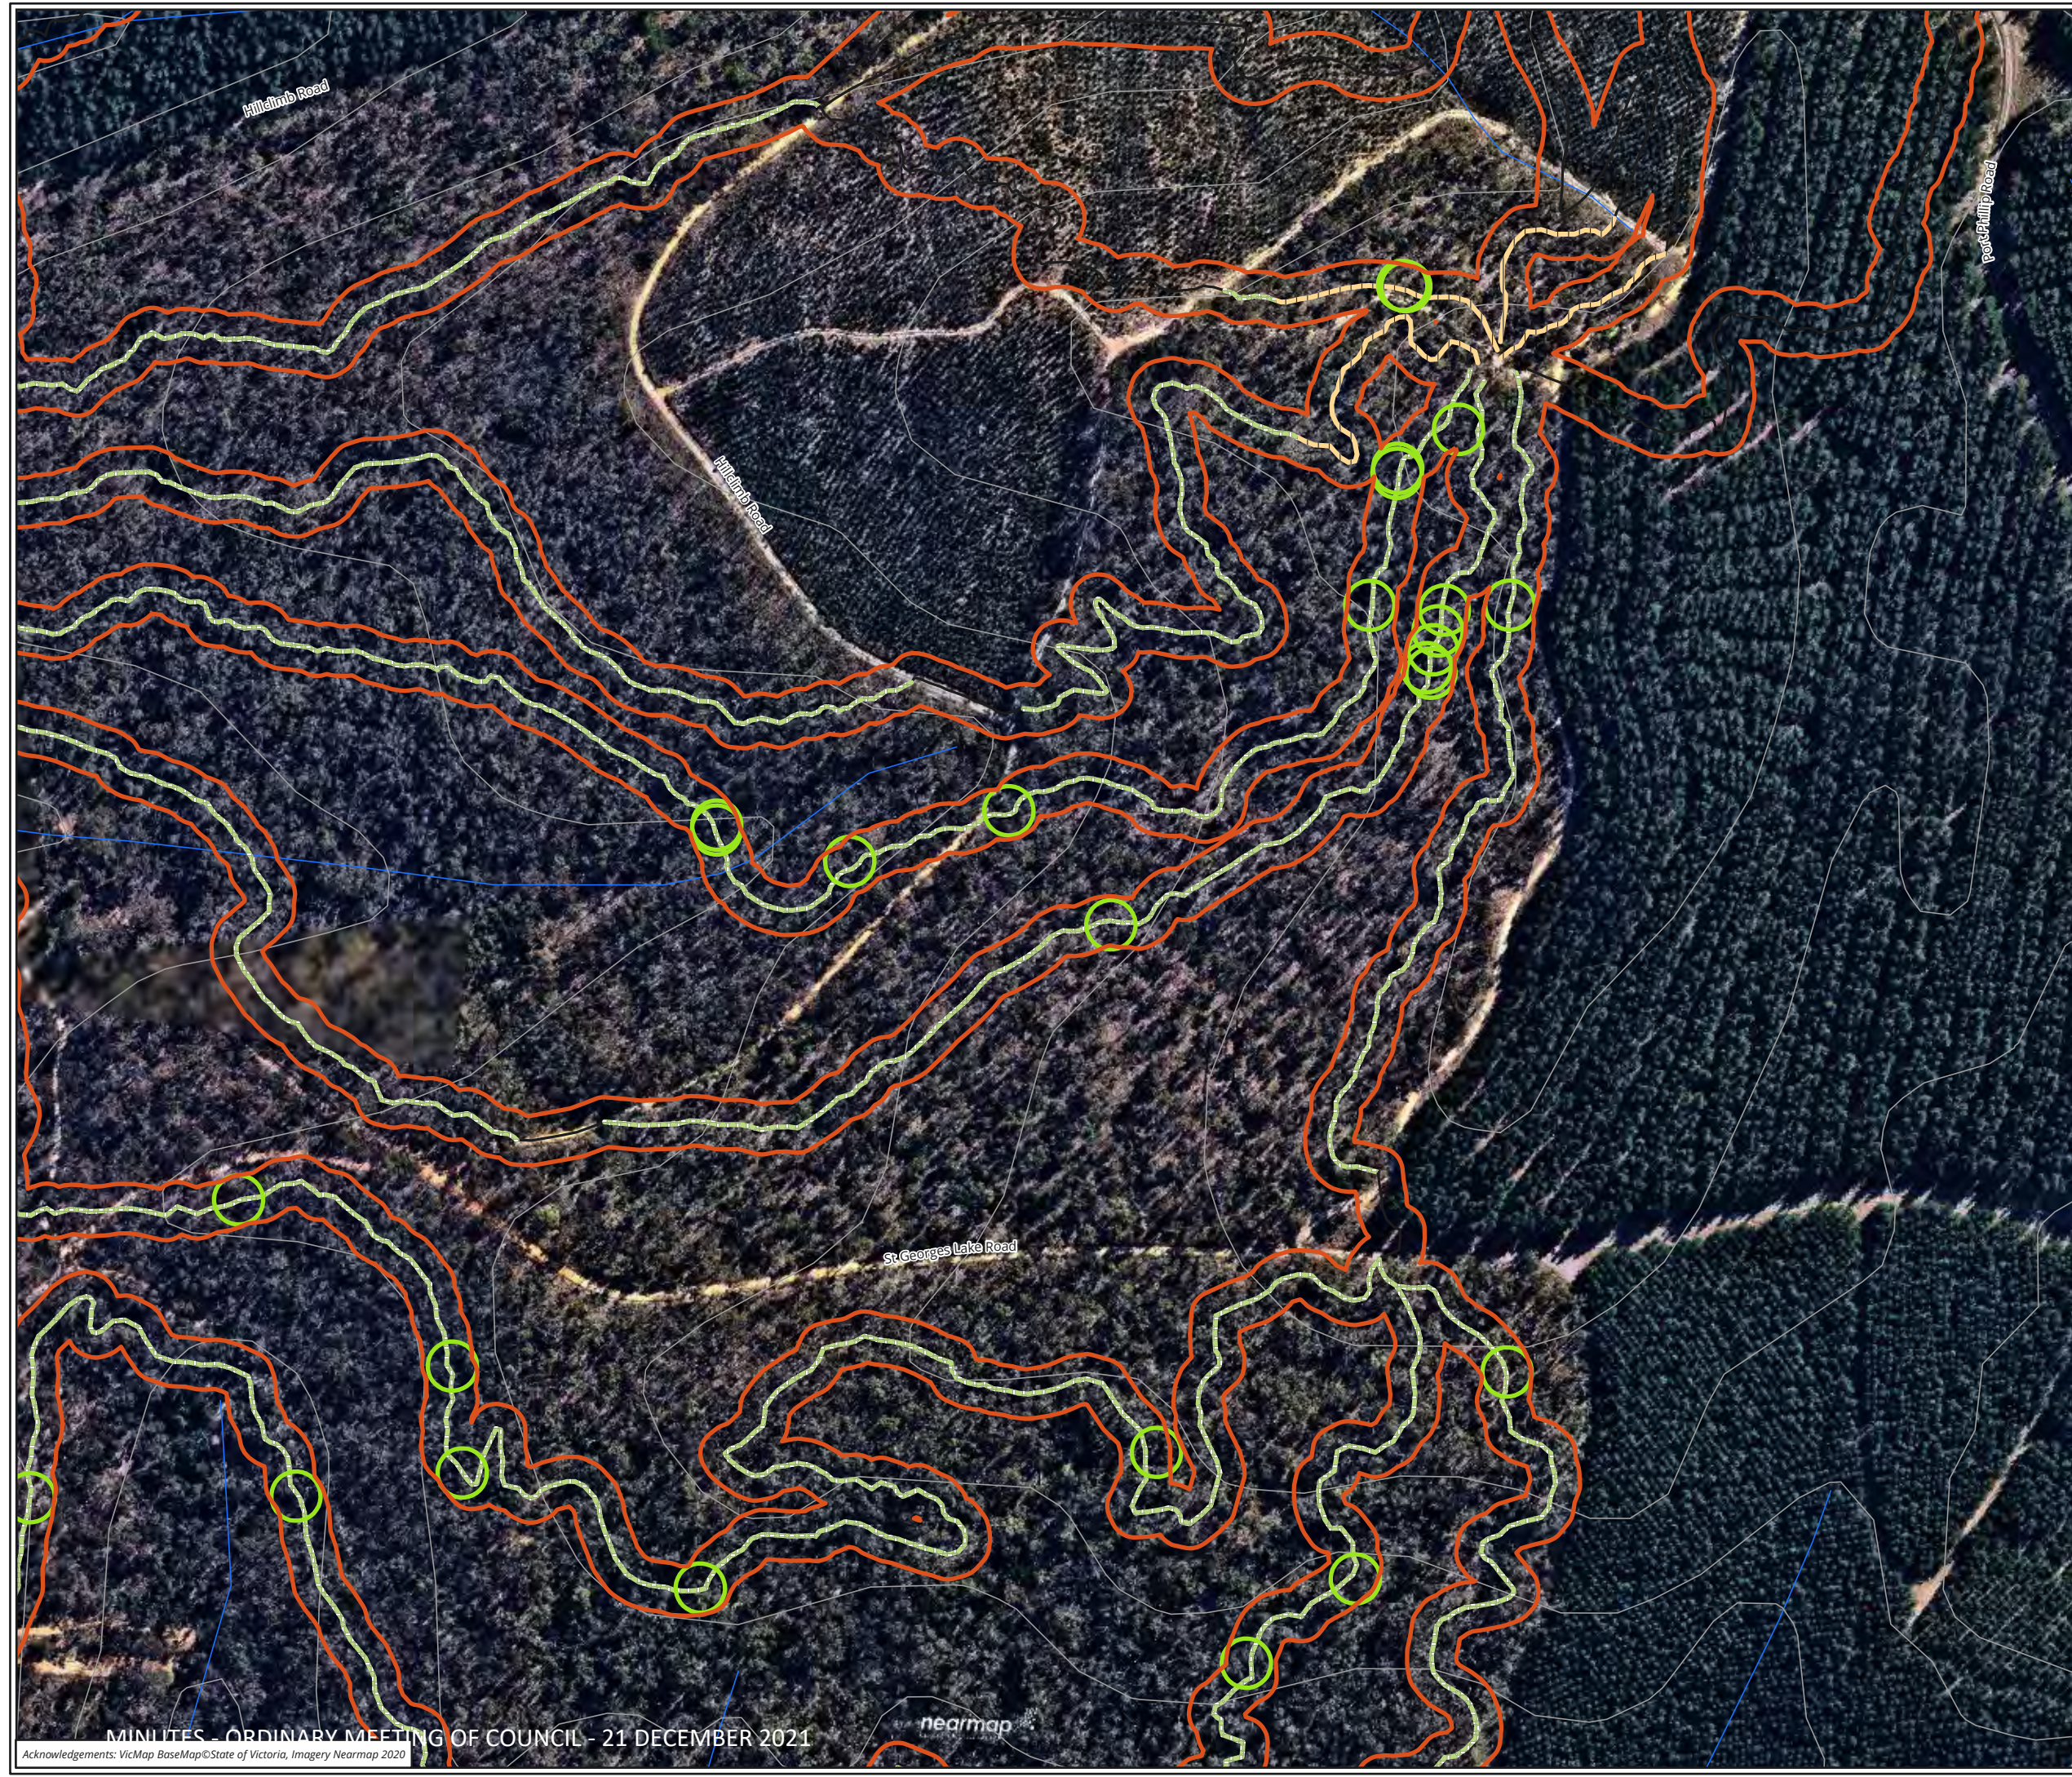
Figure 3.6 Proposed vegetation removal within the study area

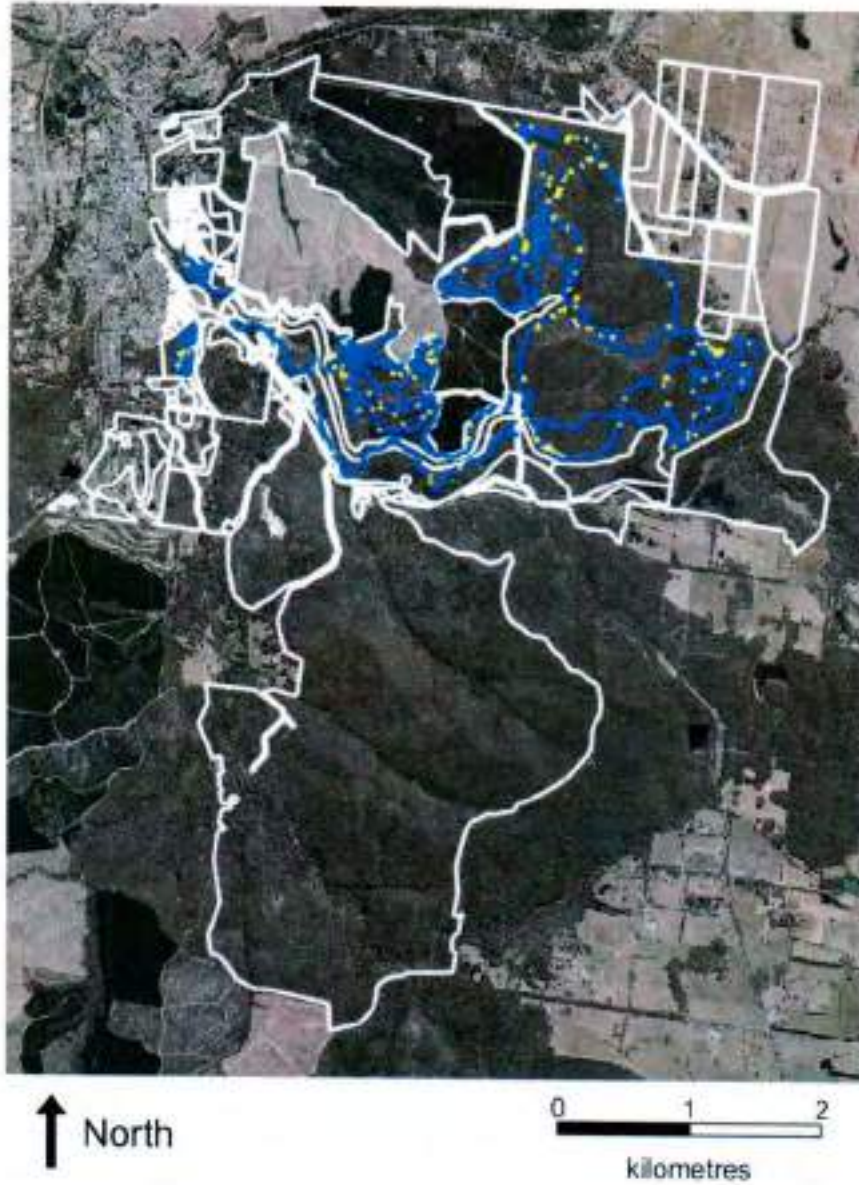
Yellow boundaries denote areas of proposed native vegetation removal.

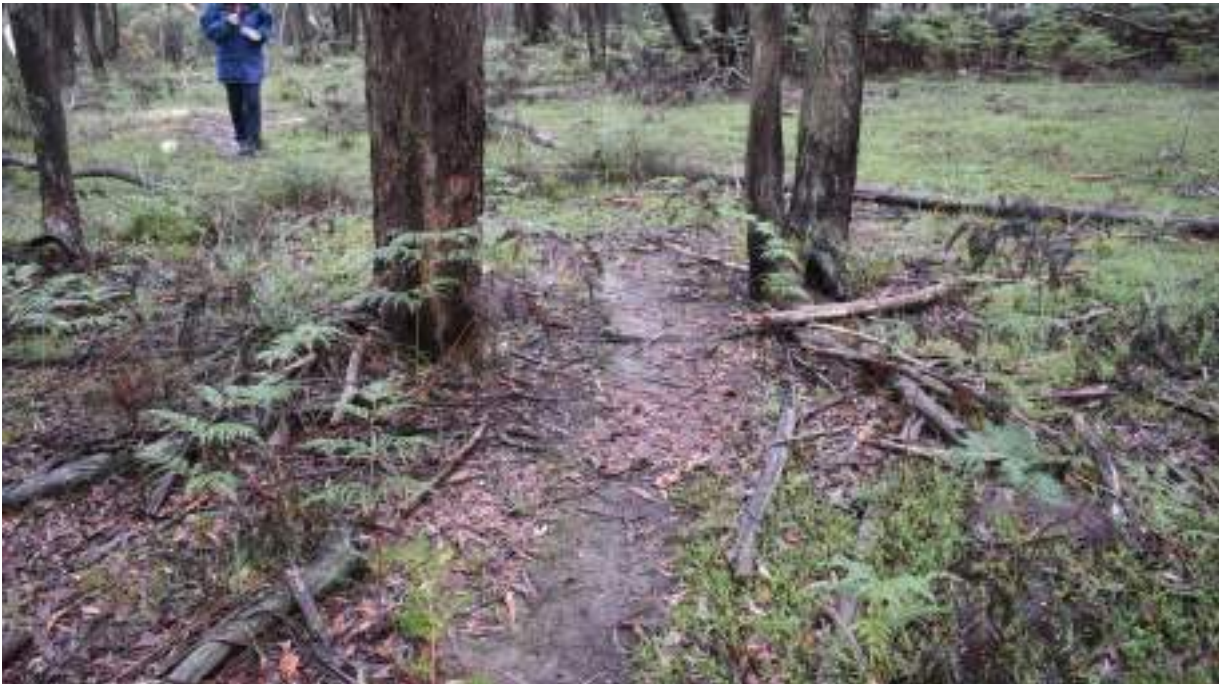
Figure 3 Example of existing trail close to trees with minimal excavation and minor compaction.

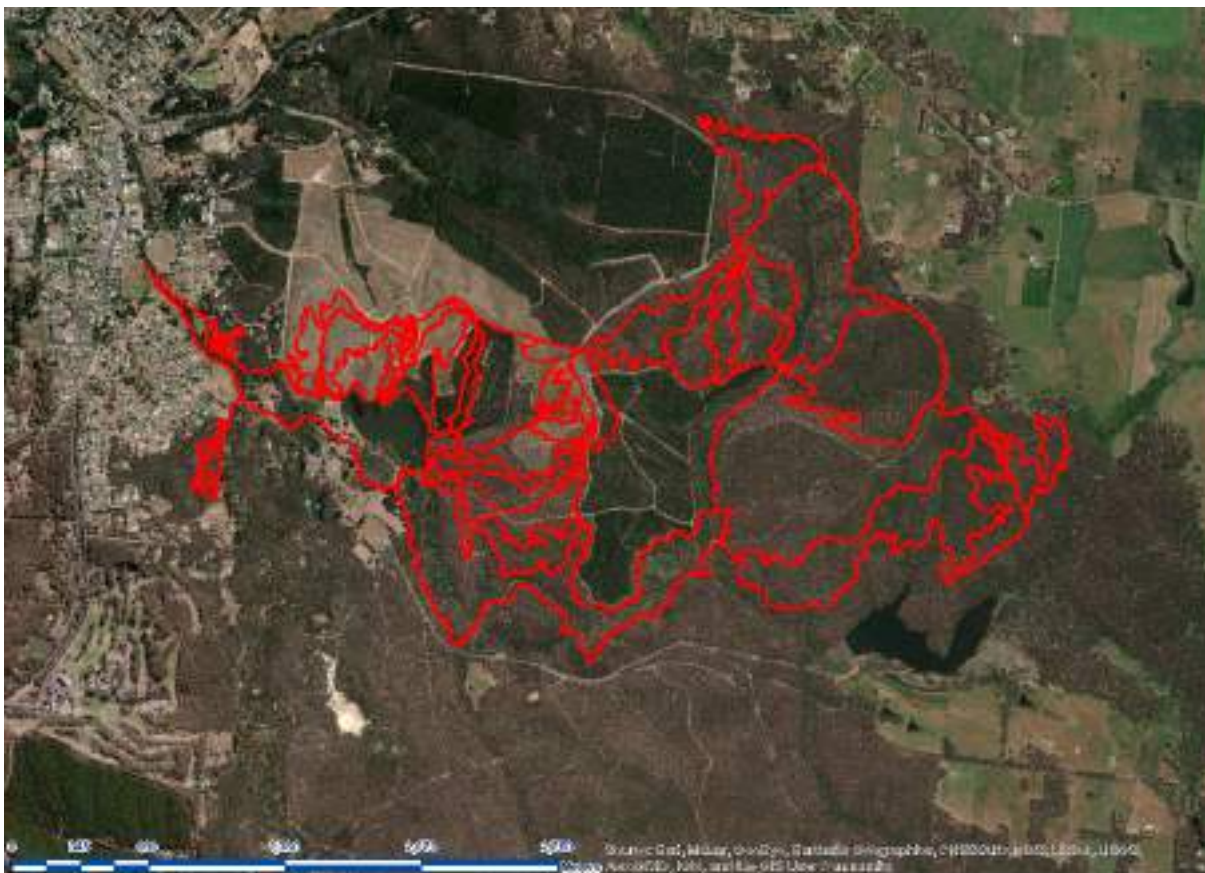
Figure 4 Mapped trail alignment highlighted red

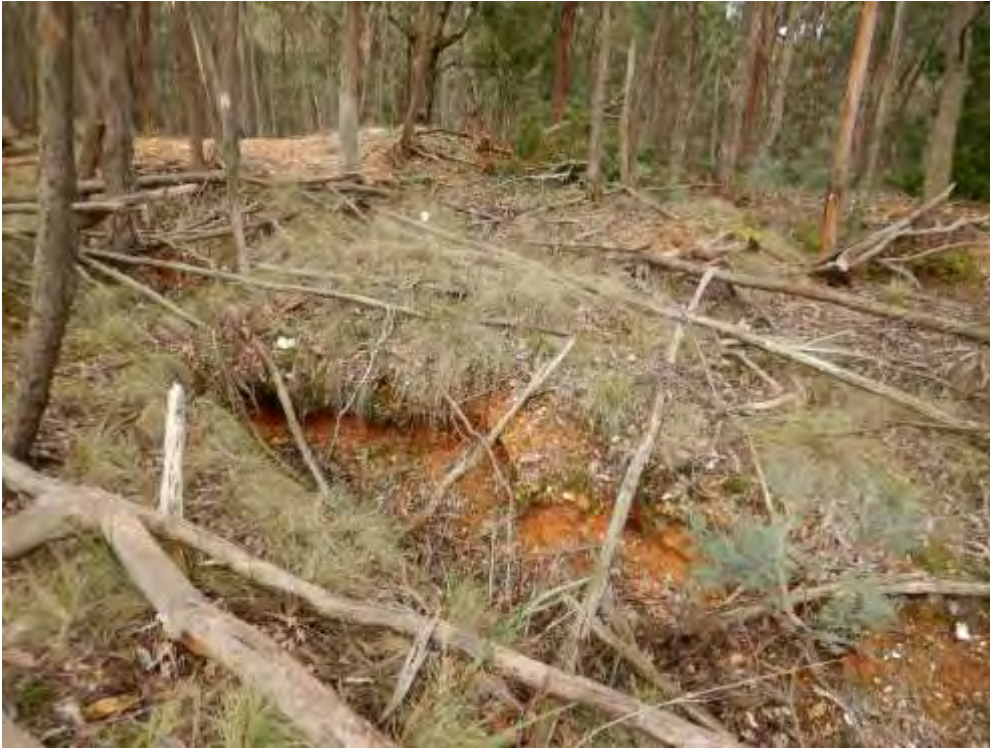
Photograph 35 Shafts and Mullock heaps, Old Shool Road Springmount (Survey Unit 58)
