OCTOBER 2025 GAS MONITORING EVENT REPORT - DAYLESFORD LANDFILL

Hepburn Shire Council

16/10/2025

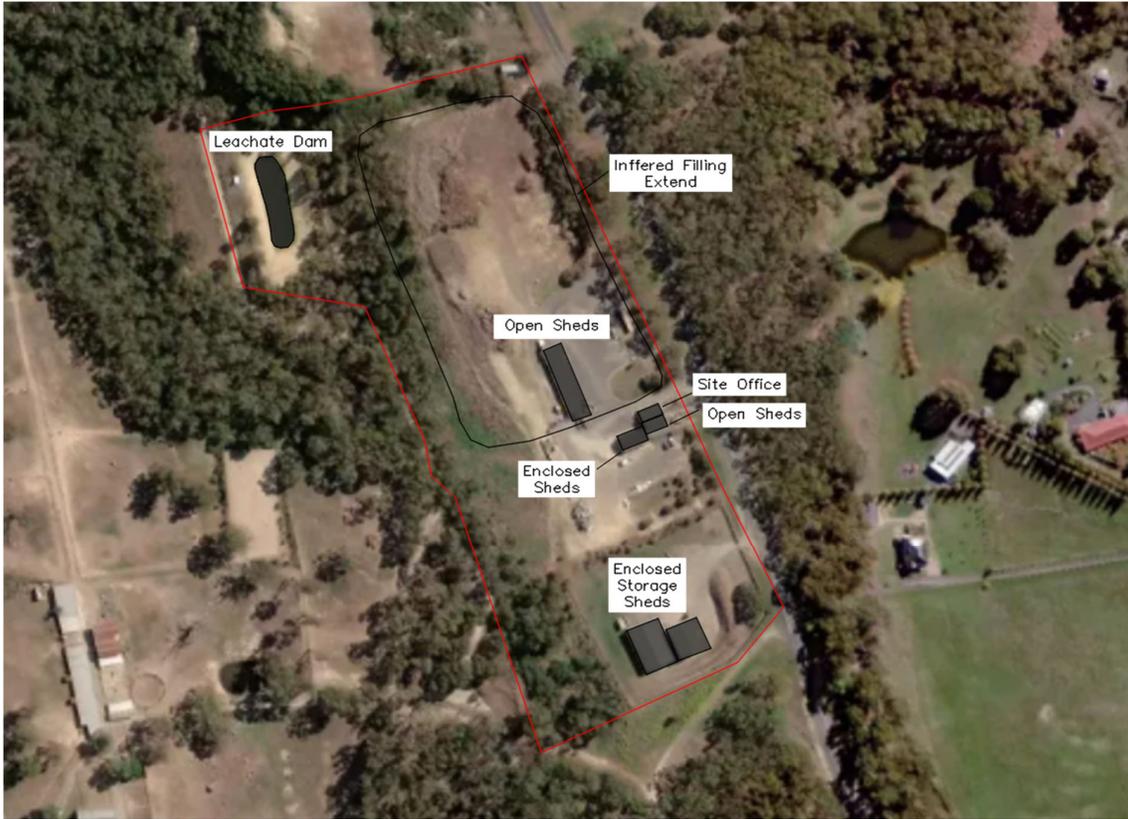
Figure 3 Buildings and Services Daylesford Landfill

According to the Landfill BPEM guidelines, for buildings and services on and adjacent to the landfill site, the acceptable methane concentration in the air is 5,000 ppm. No exceedances were recorded during any of the events included within the monitoring program. Results ranged between 0.0 ppm and 3.1 ppm, with the highest results noted at the enclosed storage shed.

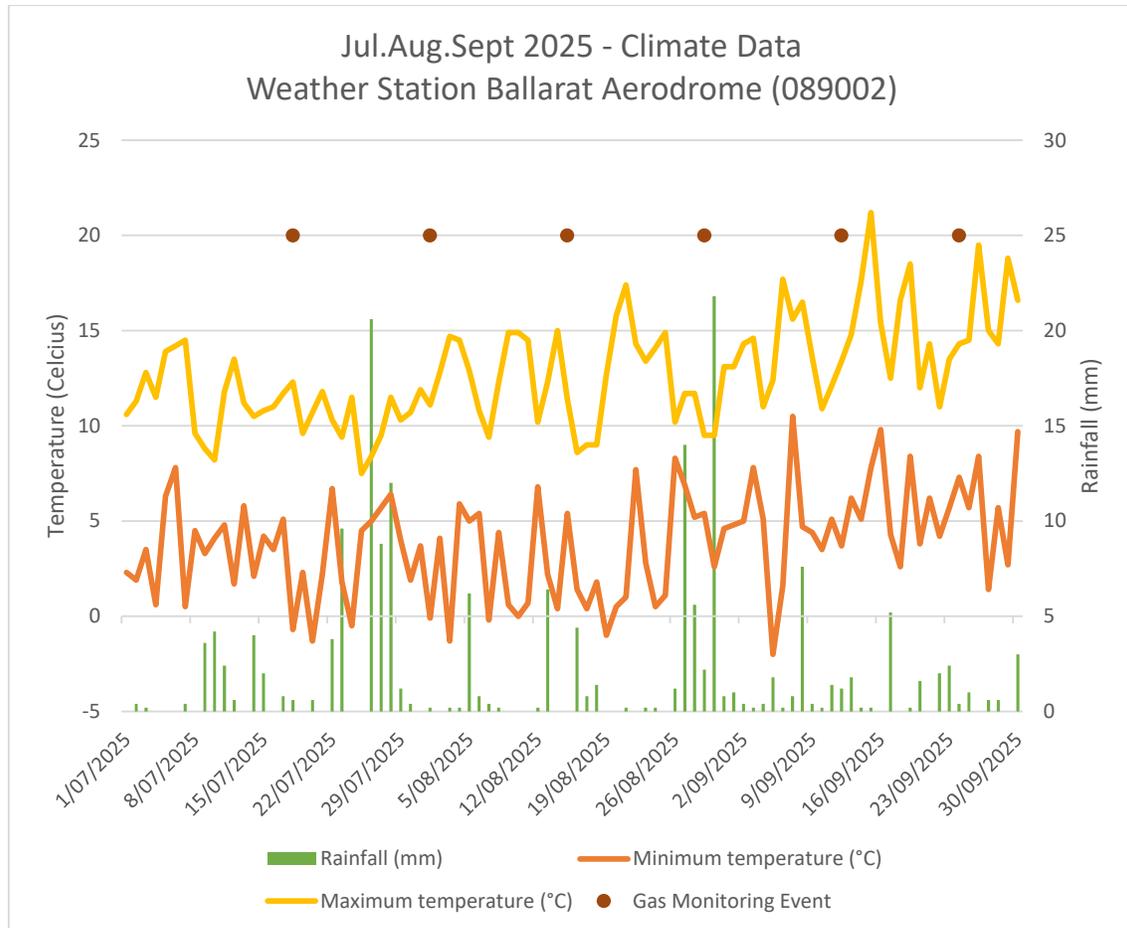
Figure 4 Temperature and rainfall readings corresponding with Ventia site visits

Rainfall was recorded to have fallen during five out of six events, with 0 mm recorded on the 15th of August 2025 and a maximum of 2.2 mm of rainfall recorded on the 29th of August. Overall 4.6 mm was recorded on gas monitoring days across the six events. A total of 178.6 mm fell across the three months over which monitoring was carried out.

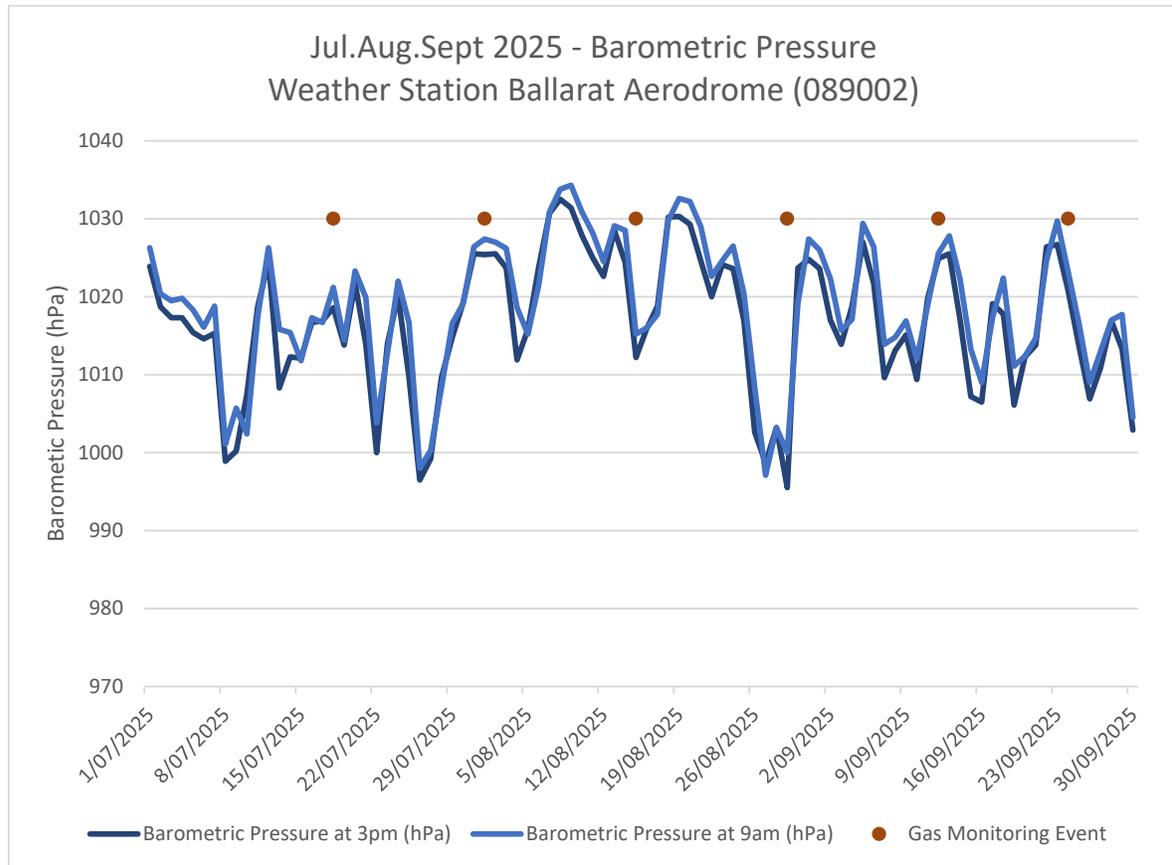
Figure 5 Daily barometric pressure readings corresponding with Ventia site visits

Internal flow and barometric pressure readings were taken immediately after connecting the gas analyser to the monitoring bore, prior to purging with negligible flows observed across the site. Internal flow readings and Barometric pressure readings during the monitoring events ranged from - 0.1 to 0.3 L/h and 940 to 962 hPa respectively.
