### QUEENS PARK CLUNES

Conservation Analysis and Conservation Policies

Originally prepared by Richard Aitken 15 February 1990

Revised and reprinted
by Wendy Jacobs
Heritage Adviser, Shire of Talbot and Clunes
June 1994

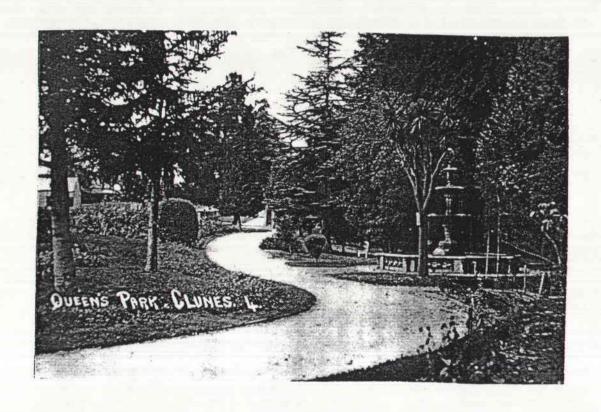
Queens Park, pictured around the turn of the century. By this date the planting had matured and the park was maintained at a high level. (Jane Lennon collection, Melbourne)

By the turn of the century, Queens Park was reaching maturity. The trees, mainly evergreen conifers, contrasted strongly with the deciduous poplars (planted along the creek in the 1880s) and "detailed" planting was evident. Neatly clipped box hedges lined a serpentine path of crushed quartz and a large cordyline was planted adjacent to the fountain. At this date many of the early plantings had been thinned and augmented with other exotic plantings, especially at the north end where a "pinetum" was cultivated. (7)
